PRODUCT SAFETY NOTICE

LADDER SAFETY SYSTEMS USING 3/8 INCH 7X19 STRAND GALVANIZED CABLE

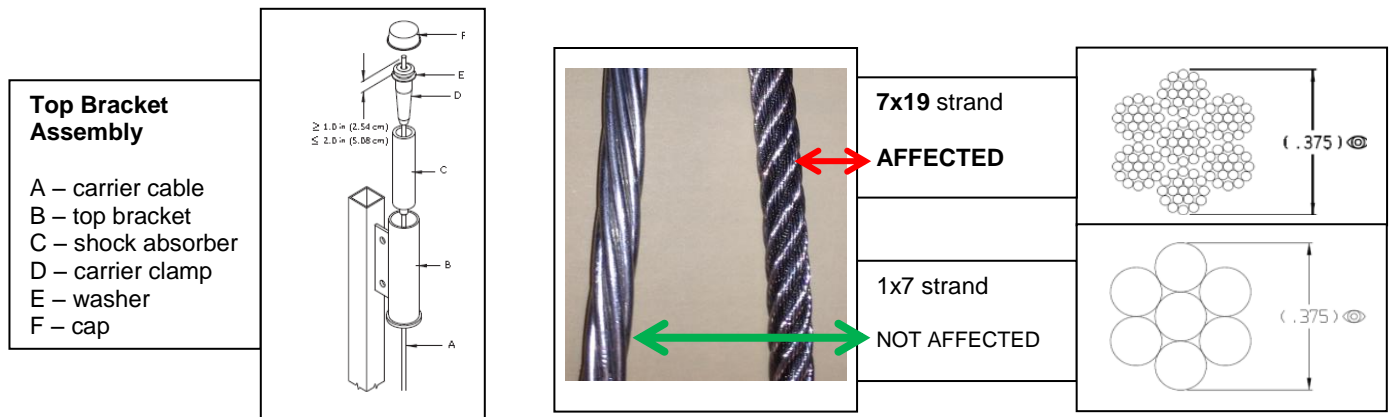
A top bracket assembly is depicted below, with diagrams and photos of **7x19** strand cable (affected) and 1x7 strand cable (not affected).

Capital Safety recommends that users: (1) inspect their systems prior to next use to determine whether 3/8 inch 7x19 strand cable is used and, if so, (2) determine whether the top bracket assemblies were purchased within the above date range.

If an affected Lad-Saf system or Safety Climb System is found, do not use the system until you have contacted Capital Safety Customer Service at 1-800-328-6146 (ext. 2012), or email us at csq.lss.inquiries@capitalsafety.com. We will answer inquiries and provide guidance on how to proceed.
